Attachment to Oct. 2, 1998 I&E of Surface Management notice (serial no. UTU 66358) -- Photographs. The location, number, and direction of photos is shown on the map attached.

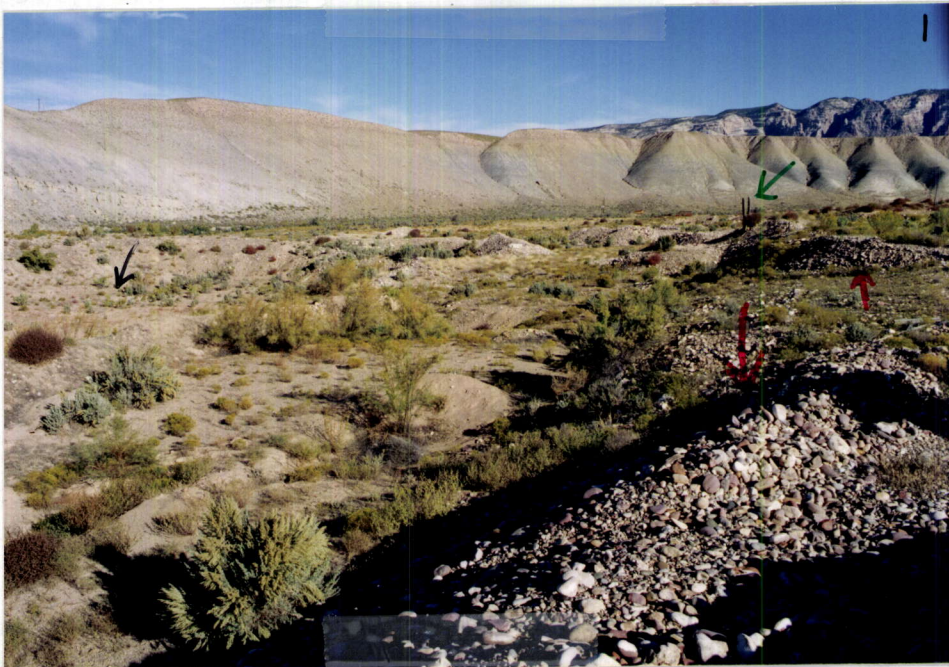
Photo 1 is a (wide angle) view to the SSE - filled drainage is in mid-photo (blue arrows), highwall cut in eastern part of project area is at left center (green arrow, see vehicle for scale), area from highwall to right center-edge of photo is the project area; there is some miscellaneous pieces of equipment left on location (at right - black arrow).

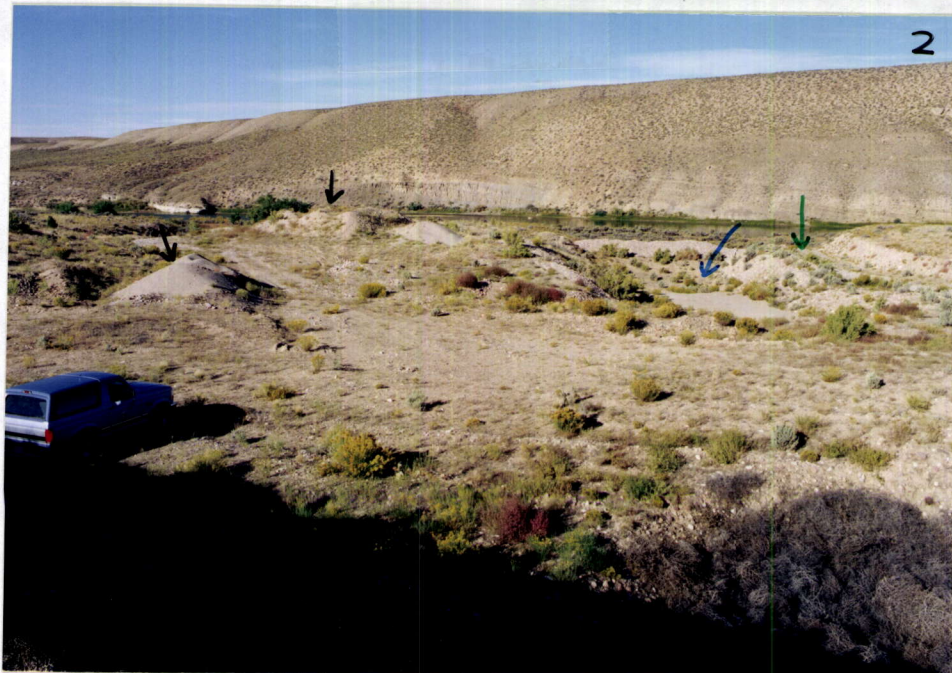
Photo 2 is a (wide angle) view to the west (from atop the highwall in photo 1) - stockpiles assumed to be top soil are at left (black arrow), old settling pond is at right (blue arrow), and road to Green River bank is at right (green arrow).
